L.E. CARPENTER & COMPANY ~ NJD002168748

Source Reduction Remedial Project Progress Update No. 7

Project Progress Update No. 7

Photographic Log Progress Update No. 7

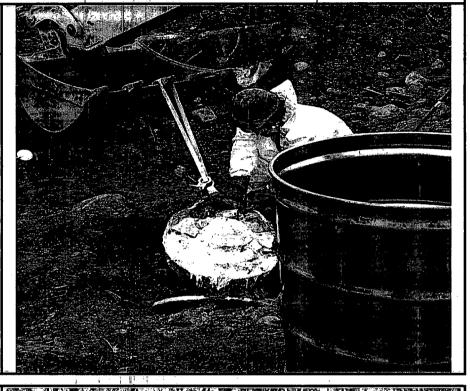
Photo No.

Date 3/4/05

Waste drum removal activities

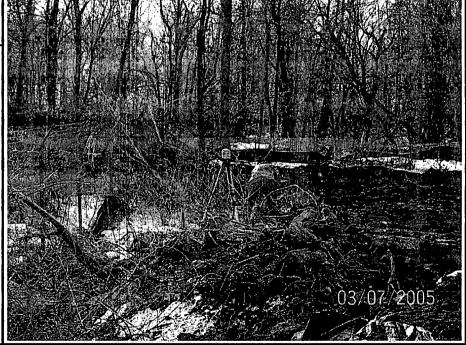
Photo No.	Date
2	3/7/05

Survey control for excavation activities (depth master)

View looking southeast towards the Rockaway River

- 16. Set up survey control for smear zone excavation (depth master)
- II. PROPOSED SOURCE REDUCTION REMEDIAL ACTIONS MARCH 11TH THROUGH MARCH 17TH 2005

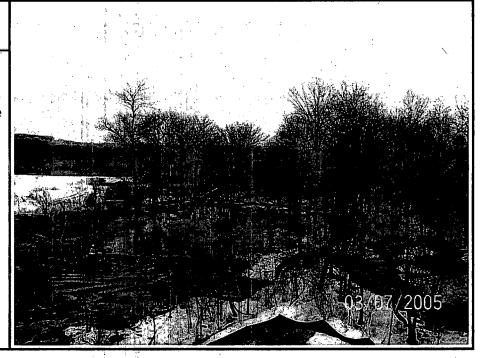
Photo No.	Date
4	3/7/05

The PCB excavation area.
Flooded due to inclement
weather and location within the
floodplain

View looking east
